# Way cover repairs help Bosch improve machine uptime

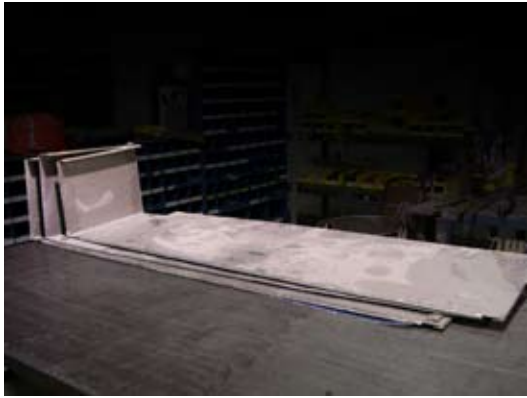
*Typically damaged way cover.*

On the 44 machining centers at the Charleston facility, as parts planner Warren Yeo explains, there are occasional breakdowns of the way covers protecting the mechanical motion components on these large work centers. Usually, these are caused by either the metal dust produced from the machining process, normal corrosion of the cover from the coolant and lubricants used, or a mechanical break in the cover, particularly fatigue on the scissors mechanism. A seemingly minor problem on a huge machining center, these breakdowns can cause substantial downtime on the factory floor, as the way covers can require considerable labor to remove, repair and replace them. “We can’t let that happen, if at all possible,” Yeo states bluntly.

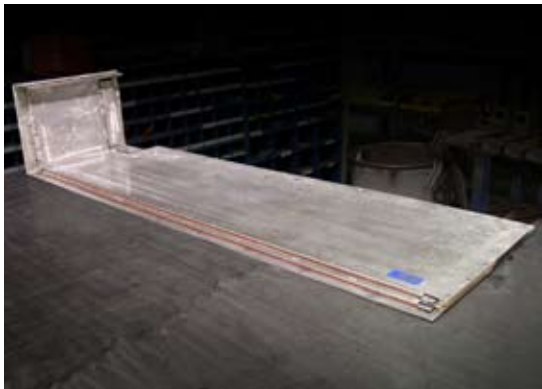
*Way cover after repair and refurbishing by Hennig, Inc.*

The repair services include replacement of wipers, straightening of box covers, replacement of rollers and V-guides, polishing and reassembly of cover boxes, replacement of side brass guides, complete refurbishing of both Hennig and other cover brands for the end-user, as well as onsite service at the customer’s facility, when needed. All types of covers are serviced at this facility, including telescoping, roll-up apron and others, as are chip conveyors and other machine tool enclosures.
